# The Esso Longford Gas Plant Accident

## Report of the Longford Royal Commission

## **The Esso Longford Gas Plant Accident Report of the Longford Royal Commission**

**JUNE 1999**

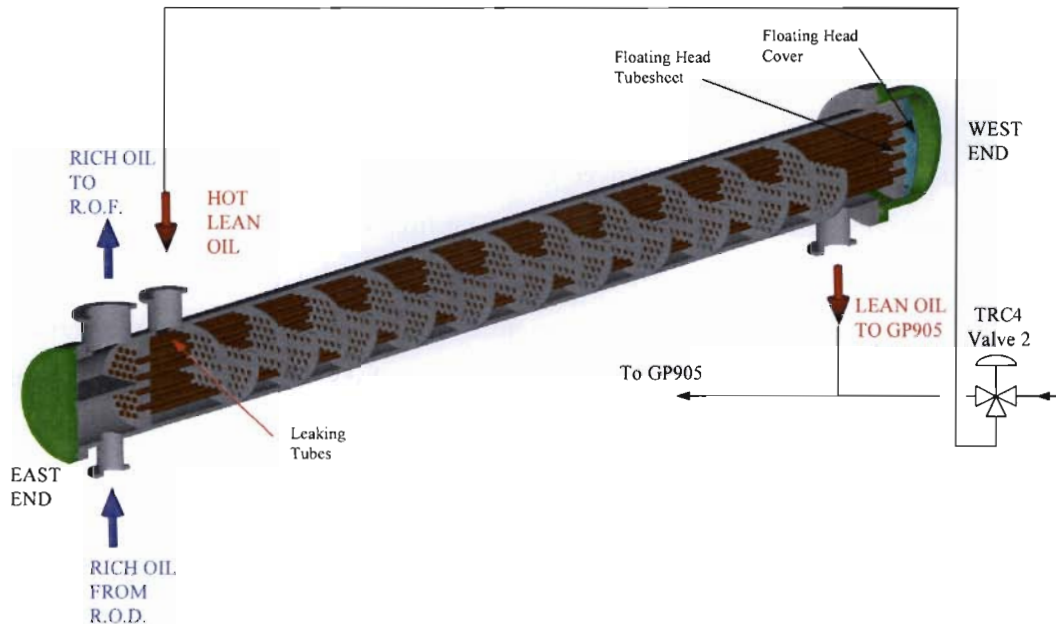
5.33 However, when the feed to the ROD became cold, the temperature at the base of the column would have fallen. TRC4 would have responded by shutting off the lean oil flow to GP922, and the lean oil would then have entered the shell via the outlet connection, and passed through the broken tubes. In this condition, the west end flange would have encountered the hot lean oil without prior cooling and the temperature difference across the western flange would have been much greater. The combination of a fibre gasket and the detailed design of the flange made it relatively intolerant to such thermal gradients and this change in temperature difference appears to have been the initial cause of the flange leaking.

**Figure 5.13 Heat exchanger GP922**

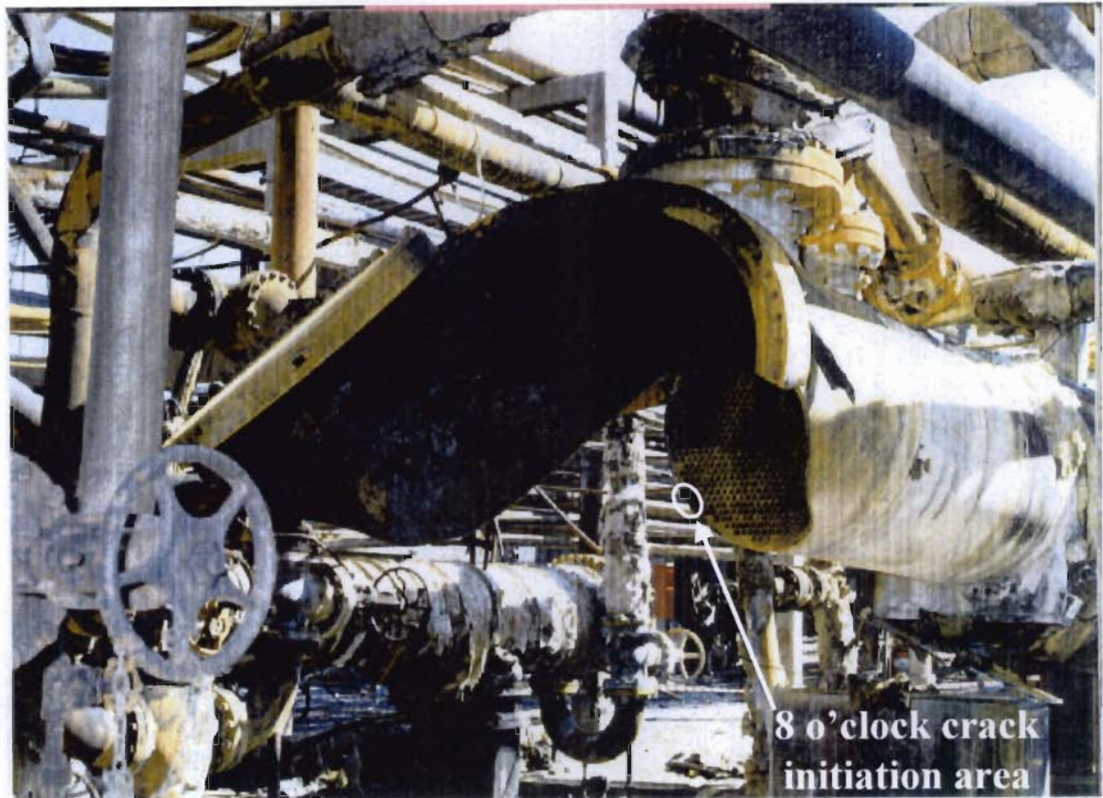
- 6.8 At the 6 o'clock position the fracture changed direction and broke into the channel. There were several smooth changes of direction before the fracture finally broke through the channel flange just below the 3 o'clock position. At this stage 30 out of the 40 flange studs broke and the channel plate peeled outwards in a clockwise direction. At 10 o'clock the fracture also broke into the channel. It headed towards the outlet nozzle stopping when it reached the nozzle's compensation pad.
- 6.9 The fracture surface for the main crack was generally flat with fine, almost parallel features, and localised ligament tearing. These features indicate the direction of the crack propagation. What the surface shows is explained in Figure 6.6.

Figure 6.4 Photograph of the failed end of GP905

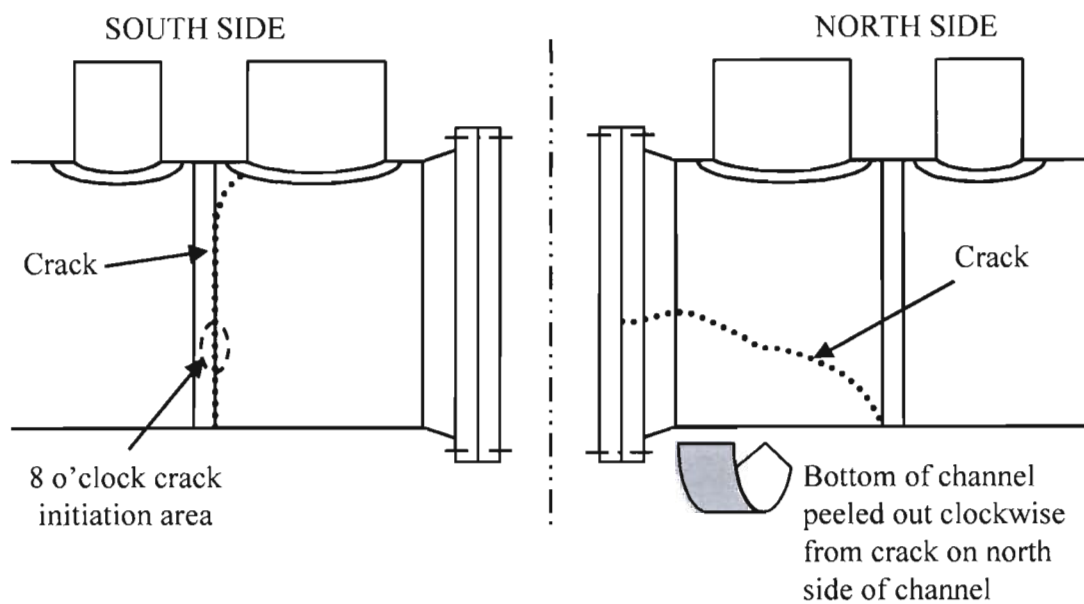
Figure 6.5 Schematic representation of the failure

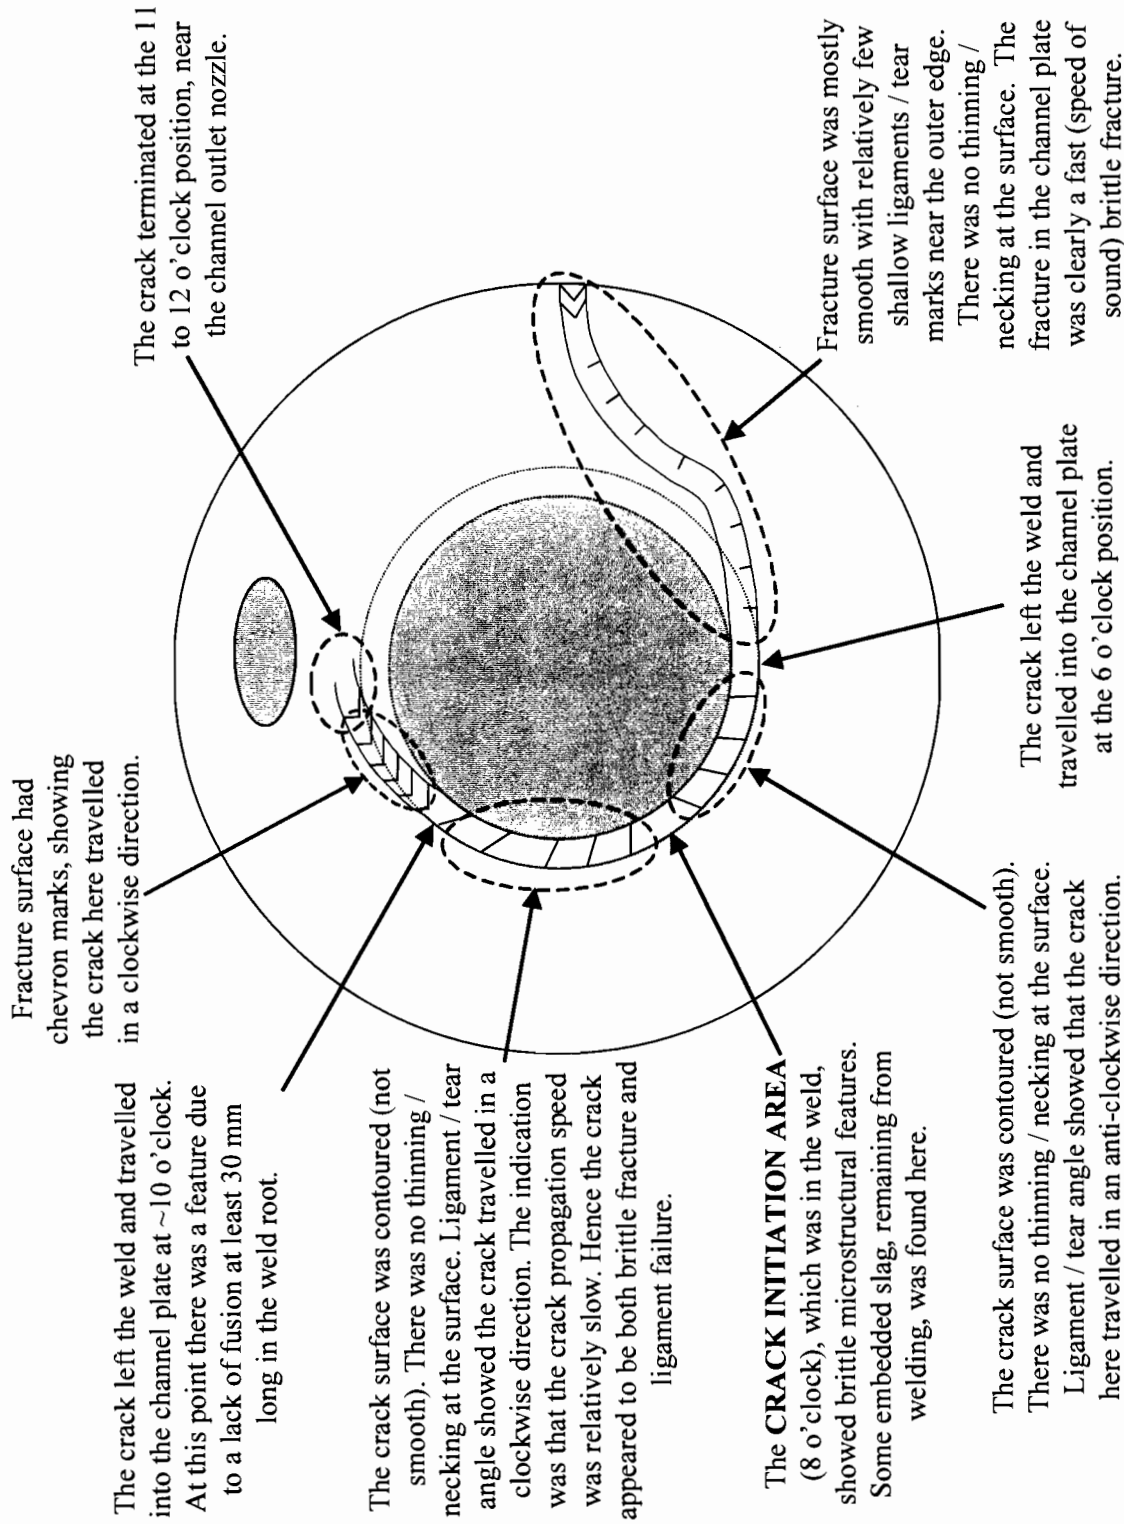
*Figure 6.6 Visible features of crack as viewed looking into the east end channel*

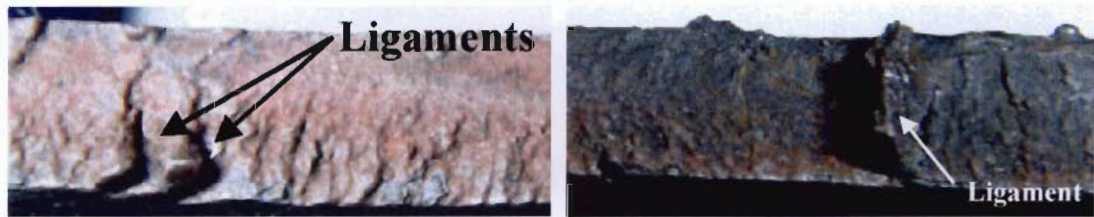
6.10 Near the 8 o'clock and 7 o'clock positions there are features on the surface that are several millimetres in height. These can be seen in Figure 6.7 and Figure 6.8. These large features are called ligaments and are indicative of localised tensile overload. The angle of these ligaments and other surface markings indicate that the crack origin lay in the 7 o'clock and 8 o'clock region. The featured surface and ligaments indicate that the crack propagated slowly while it was in the weld. It should be noted that the term "slowly" is used in a relative sense, and is in contrast to a pure brittle fracture where the crack propagates at the speed of sound (fast) leaving a smooth surface.

*Figure 6.7 Ligaments at the 7 o'clock position*

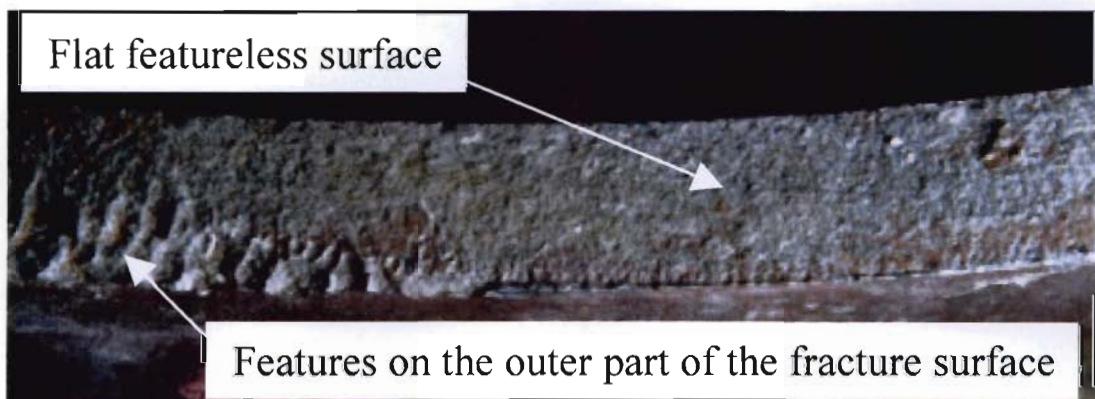
6.11 By contrast the failure surface in the channel plate (between 6 o'clock and just before 3 o'clock) is smoother, see Figure 6.9. It is flat and featureless on the inner surface, but has noticeable markings on the outer surface. It can therefore be concluded that the crack's propagation speed in the channel plate was faster than it was in the tubesheet to channel weld. It is concluded that the failure in the channel was fast brittle fracture.

*Figure 6.9 Close-up of the channel's fracture surface (around 5 o'clock)*

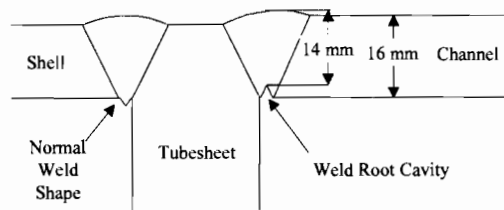
**Figure 6.10 Weld root cavity**

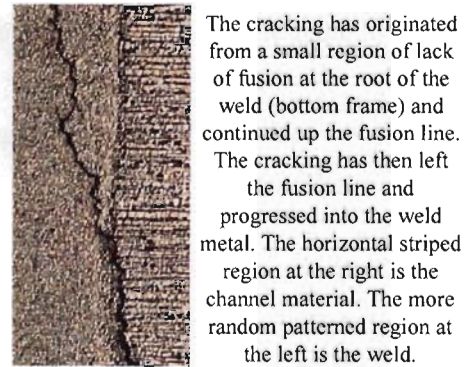
The cracking has originated from a small region of lack of fusion at the root of the weld (bottom frame) and continued up the fusion line. The cracking has then left the fusion line and progressed into the weld metal. The horizontal striped region at the right is the channel material. The more random patterned region at the left is the weld.

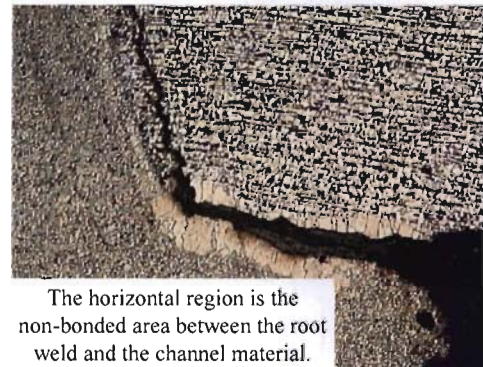
The horizontal region is the non-bonded area between the root weld and the channel material.

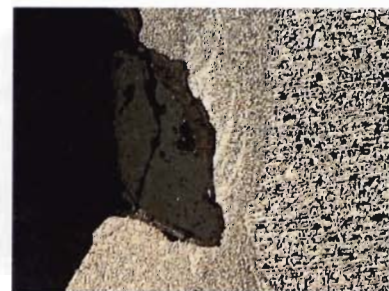
**Figure 6.15 Weld root slag inclusion at 8 o'clock position**

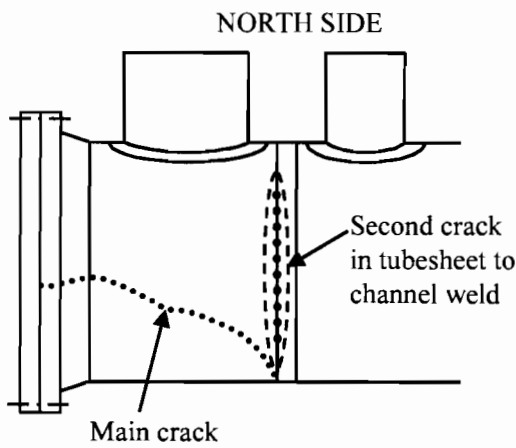
**Figure 6.16** Second crack in tubesheet to channel weld

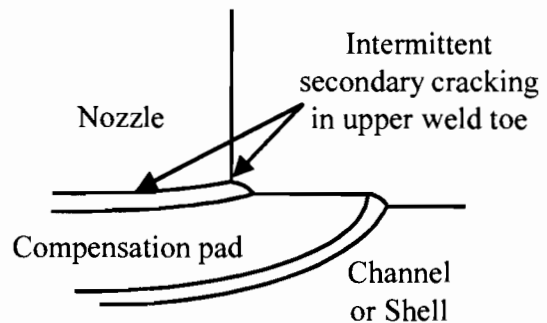
**Figure 6.17** Location of the secondary cracks in the compensation pads

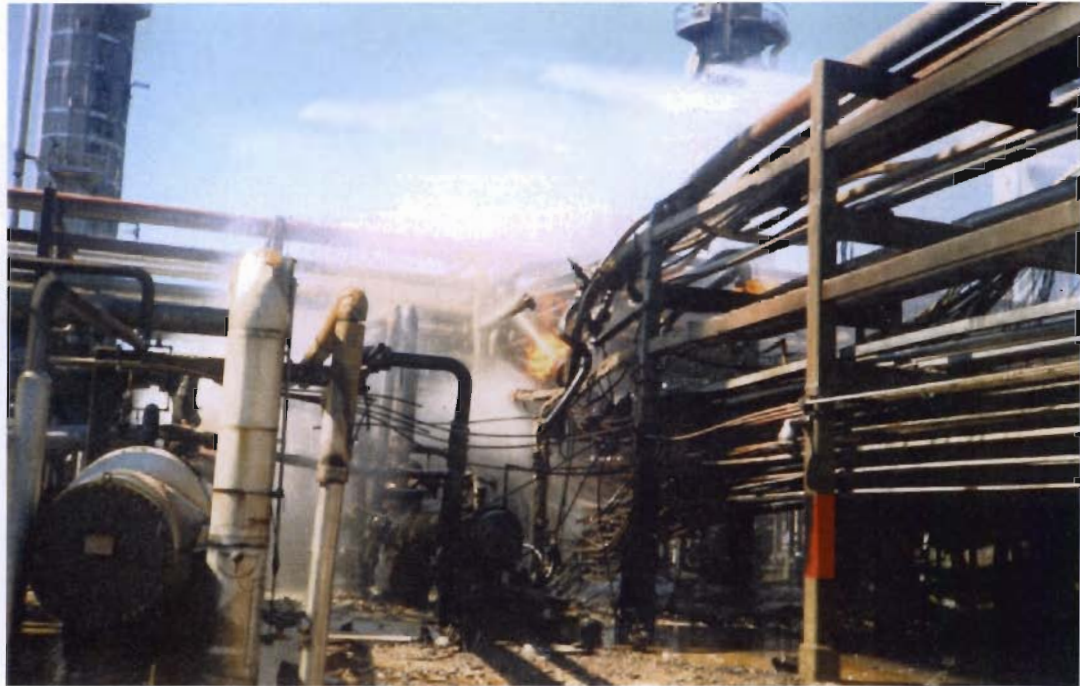
*Figure 7.16 Photograph taken at approximately 14:45 pm, 26 September, showing seats of fire in Kings Cross piperack*

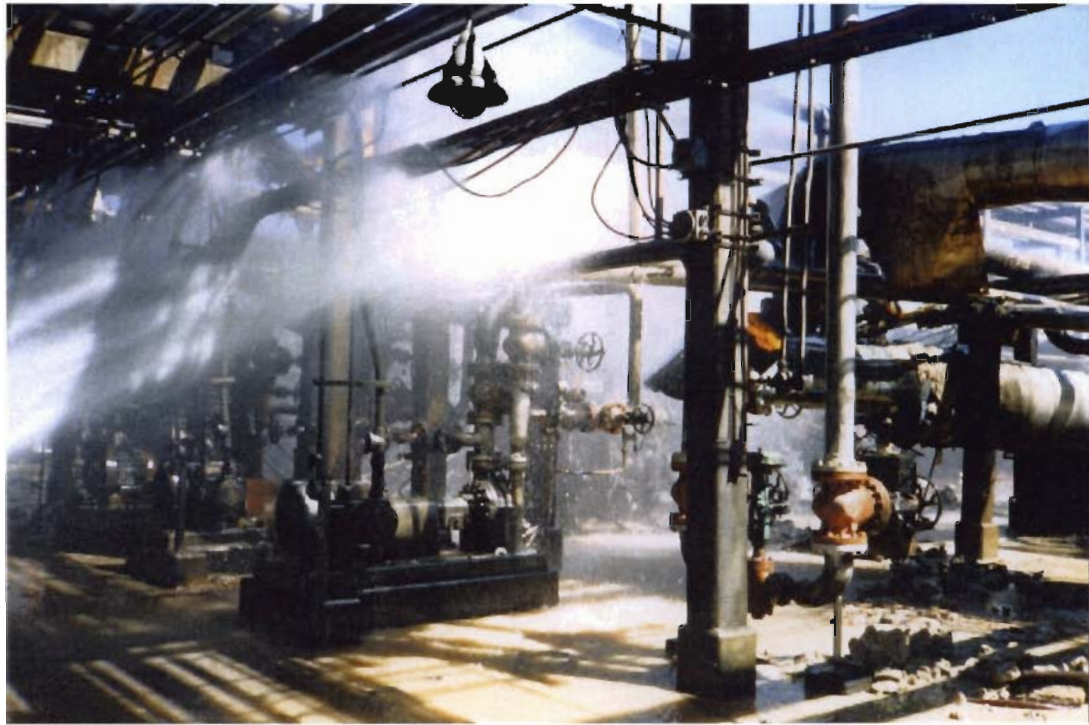
*Figure 7.17 Photograph taken at approximately 15:00, 26 September, fire still burning from GP905*
